Secondary instability to tearing modes in JET density limit disruptions

F. Salzedas^{1,2}, and JET EFDA Contributors*

JET EFDA, Culham Science Centre, Abingdon, OX14 3DB, UK

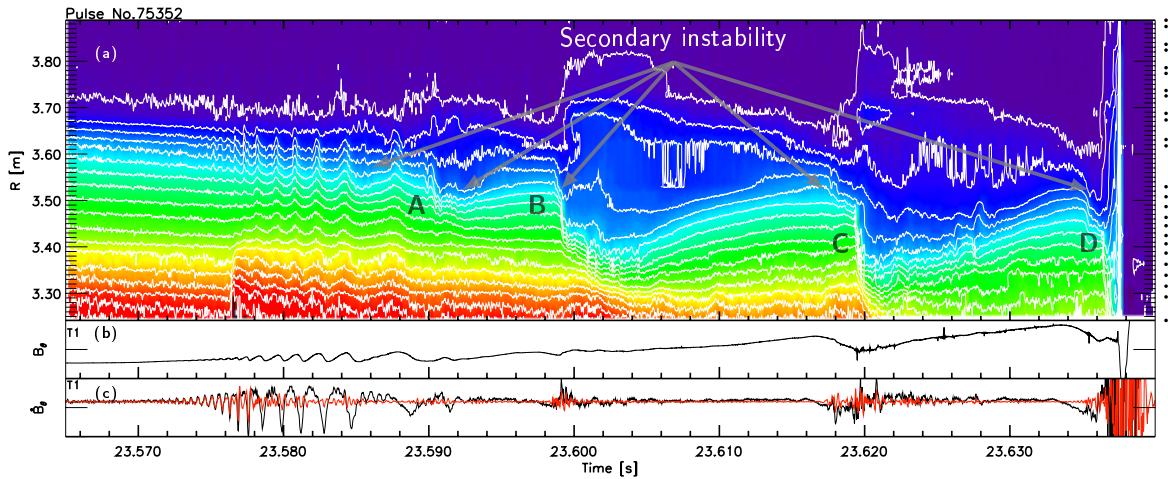
Figure 1: (a) Electron temperature $T_e(r,t)$ isotherms. The ECE channels position is indicated by the dots at the right side. (b) $B_\theta(t)$, numerically integrated. (c) $\dot{B}_\theta(t)$ and the same signal high pass filtered (in red) with a cut-off frequency of 2 kHz. In this pulse, $I_p = 1.7$ MA, $q_{95} = 3.5$, $B_\phi = 2.7$ T and $\bar{n}_e = 2.15 \times 10^{19}$ m⁻³.

A typical discharge where the SI was observed will be used to illustrate some of its properties as well as its relation with minor disruptions and the 2/1 tearing mode. Figure 1(a) shows the

evolution of the electron temperature profile $T_e(R, t)$ at the high field side of the plasma, around the $q = 2$ surface, in the last 70 ms before a major disruption destroys the plasma thermal energy confinement at 23.639 s. ECE time resolution is $4\ \mu\text{s}$, and isothermals starting at 30 eV increase in steps of 100 eV. To each ECE channel was applied a low pass finite impulse response filter with a cut off frequency of 10 kHz to eliminate a high frequency component that hides the observations here addressed. The figure focus on the Low Field Side (LFS) part of the profile, spanning the region from the edge to $q \approx 1$.

The characteristic signature of an $m/n = 2/1$ tearing mode is the oscillation, starting with small amplitude at 3.62 m and 23.572 s. The magnetic island rotation frequency slows down from ≈ 2 kHz to ≈ 50 Hz, never locking completely to the wall. The frequency decreases as the island size increases due to island interaction with the conducting tokamak wall. From coherence analysis between $T_e(R, t)$ and $\dot{B}_\theta(t)$ the radial position of the $q = 2$ rational surface is found at ≈ 3.62 m [2].

Four distinct events, labeled A, B, C and D respectively exhibit large heat flows across the $q = 2$. During these events the heat flux is directed to the plasma edge, as indicated by the increase in plasma edge temperature that follows. Heat lost during event A is smaller compared with the other three events. One particular feature common to all these four events is that the sudden heat flux is triggered at the same time a local oscillation, secondary to the 2/1 oscillation, experiences an increase in amplitude. This secondary instability is already present in the plasma before event A occurs, but with a lower amplitude. Due to low spatial coverage of the region around $q = 2$ surface by the fast ECE radiometer channels, combined with higher noise level of the edge channels, it was difficult to follow the SI with this diagnostic, during the 2/1 mode fast rotating phase.

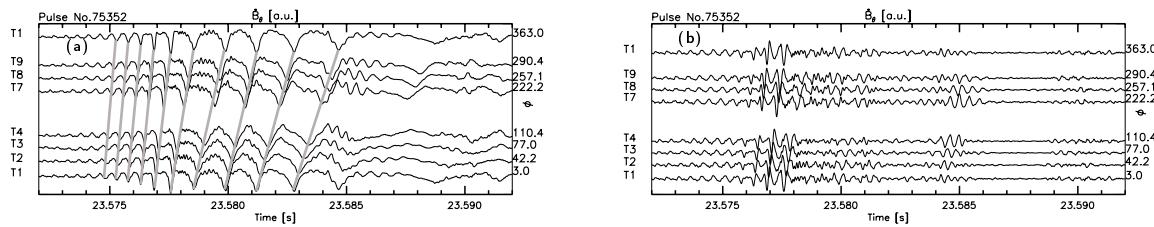
Figure 2: (a) Toroidal array of $\dot{B}_\theta(t)$ coils. (b) Same signals high pass filtered with a cut-off frequency of 2kHz, in order to decrease the $m/n = 2/1$ component.

Both the 2/1 magnetic island and the secondary instability are detected also by magnetic coils. Figure 2(a) shows \dot{B}_θ signals from a toroidal array of coils during the fast rotating phase of the magnetic island. Two different oscillations are observed. One with large increasing amplitude and decreasing frequency (from about 2 kHz to 100 Hz) and another smaller amplitude oscillation at frequencies generally above 2 kHz. The gray lines connecting the minima, of the large amplitude oscillations, of the signals from different coils show that the magnetic island has a toroidal mode number $n = 1$. A similar exercise to find the toroidal mode number of the SI fails as neighbour coils do not always detect the same number of minima. Moreover the small amplitude oscillations from the SI are not seen over a complete period of the 2/1 mode oscillation, a feature more clear in the slow rotating phase of the 2/1 island. During the minor disruption the SI is present only in part of the low q side of the 2/1 island O point, causing the asymmetric heat

flux across the $q = 2$ surface. These observations are consistent if the SI has no toroidal mode number. Information from a poloidal array of coils and the localization of the SI was discussed at [2]. From Figure 1(c) (red curve) and Figure 2(b) it is possible to infer the intermittent growth rate of the SI. These figures show \dot{B}_θ high pass filtered with a cut-off frequency of 2kHz with the purpose to decrease the 2/1 component in the signal.
